Office of Sport

Asbestos and Hazardous Materials Reinspection Assessment

Borambola Sports & Recreation Centre

03/02/2023

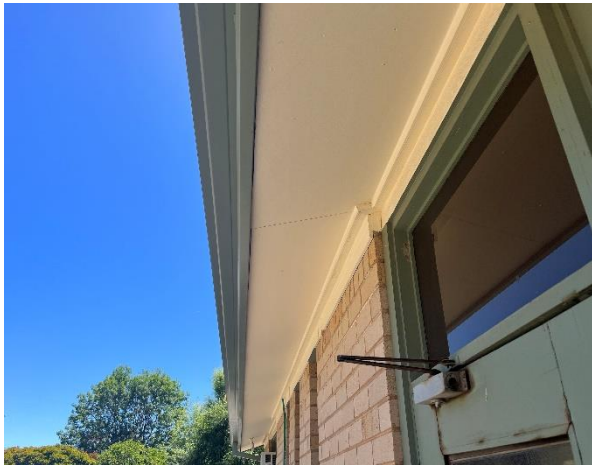
Line ID 2: External, Building 10 General Managers Office, Perimeter Verandas, Eaves, Fibre Cement Sheet - Chrysotile Asbestos Detected

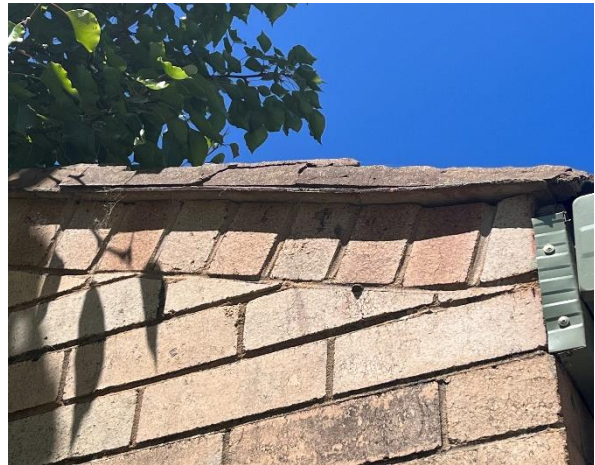
Line ID 3: External, Building 10 General Managers Office, Perimeter Verandas, Gable End Tile Support Strips, Fibre Cement Sheet - Chrysotile Asbestos Detected

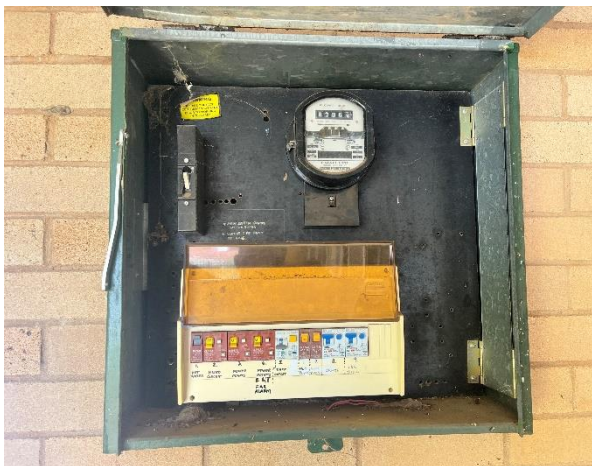
External	Building 10 General Managers Office / Perimeter Verandas / South Side Electrical Box	Bituminous Backing Board	Asbestos	Previously Sampled AF495	Chrysotile Asbestos Detected	Non-Friable	1 Unit	Low	5 Yearly Reinspection	Label as containing asbestos and maintain in current condition if to remain in-situ. Remove under controlled non-friable asbestos removal conditions prior to refurbishment or demolition works by a Class B (non-friable) licensed asbestos removal contractor in accordance with relevant State Regulations, Compliance Codes, Codes of Practice and Guidance Notes.	4

Line ID 4: External, Building 10 General Managers Office, Perimeter Verandas, South Side Electrical Box, Bituminous Backing Board - Chrysotile Asbestos Detected

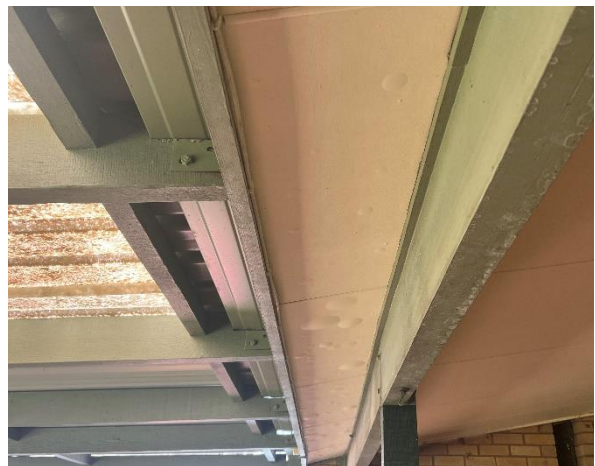
Line ID 6: External, Building 11 Service Coordinator Residence, Perimeter Verandas, Eaves, Fibre Cement Sheet - Chrysotile Asbestos Detected

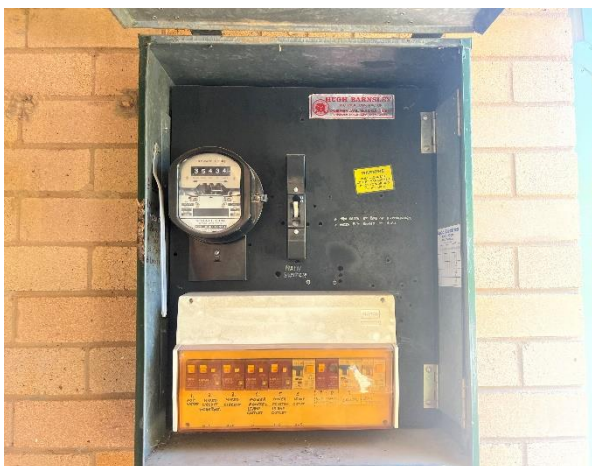
External	Building 11 Service Coordinator Residence / Perimeter Verandas / Southside Electrical Box	Bituminous Backing Board	Asbestos	Previously Sampled AF495.1	Chrysotile Asbestos Detected	Non-Friable	1 Unit	Low	5 Yearly Reinspection	Label as containing asbestos and maintain in current condition if to remain in-situ. Remove under controlled non-friable asbestos removal conditions prior to refurbishment or demolition works by a Class B (non-friable) licensed asbestos removal contractor in accordance with relevant State Regulations, Compliance Codes, Codes of Practice and Guidance Notes.	8

Line ID 8: External, Building 11 Service Coordinator Residence, Perimeter Verandas, Southside Electrical Box, Backing Board - Chrysotile Asbestos Detected

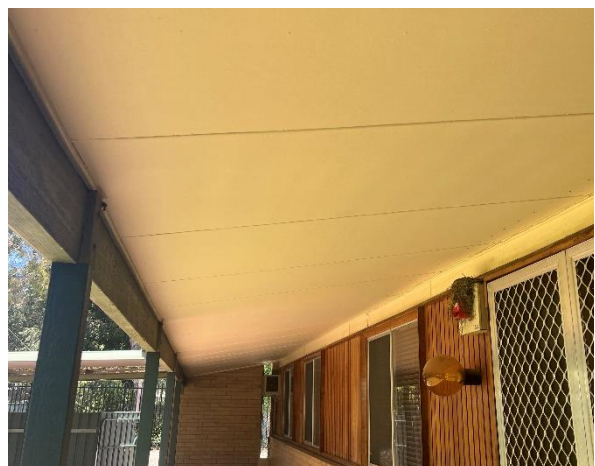
Line ID 9: External, Building 11 Service Coordinator Residence, Perimeter Verandas, Veranda Ceiling Lining, Fibre Cement Sheet - Chrysotile Asbestos Detected

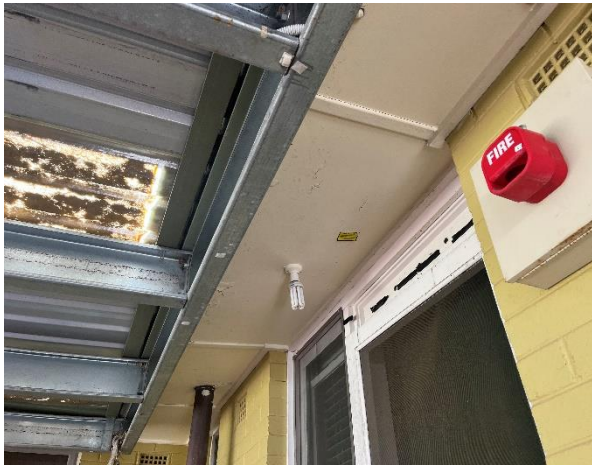
Area	Location	Material Description	Hazard	Reference No.	Result	Friable	Quantity	Risk Rating	Reinspect Date	Recommendations	Line ID
External	Building 11 Service Coordinator Residence / Perimeter Verandas / Veranda Ceiling Lining	Fibre Cement Sheet	Asbestos	Previously Sampled EP-137.1	Chrysotile Asbestos Detected	Non-Friable	40 m²	Low	5 Yearly Reinspection	Label as containing asbestos and maintain in current condition if to remain in-situ. Remove under controlled non-friable asbestos removal conditions prior to refurbishment or demolition works by a Class B (non-friable) licensed asbestos removal contractor in accordance with relevant State Regulations, Compliance Codes, Codes of Practice and Guidance Notes.	9
External	Building 12 Client Services Coordinator Residence / Car Port / Lower Wall Lining	Fibre Cement Sheet	Asbestos	Previously Sampled AF497.1	No Asbestos Detected	-	0 m²	-	-	-	10
External	Building 12 Client Services Coordinator Residence / Perimeter Verandas / Eaves	Fibre Cement Sheet	Asbestos	Previously Sampled EP-168	Chrysotile Asbestos Detected	Non-Friable	25 m²	Low	5 Yearly Reinspection	Label as containing asbestos and maintain in current condition if to remain in-situ. Remove under controlled non-friable asbestos removal conditions prior to refurbishment or demolition works by a Class B (non-friable) licensed asbestos removal contractor in accordance with relevant State Regulations, Compliance Codes, Codes of Practice and Guidance Notes.	11

Line ID 11: External, Building 12 Client Services Coordinator Residence, Perimeter Verandas, Eaves, Fibre Cement Sheet - Chrysotile Asbestos Detected

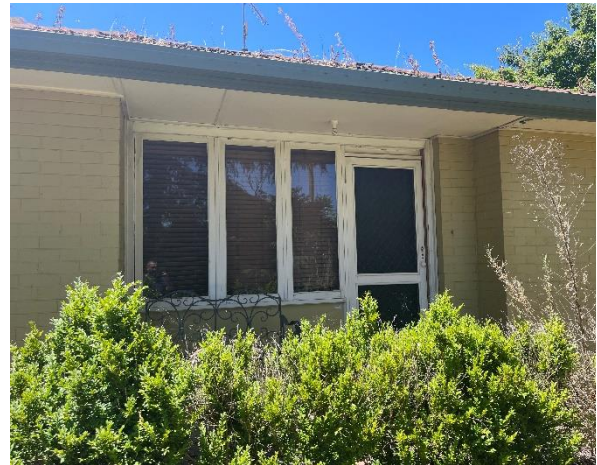
External	Building 12 Client Services Coordinator Residence / Perimeter Verandas / External Bathroom and Kitchen Wall Lining	Fibre Cement Sheet	Asbestos	Previously Sampled EP-168.4	Chrysotile Asbestos Detected	Non-Friable	40 m²	Low	5 Yearly Reinspection	Label as containing asbestos and maintain in current condition if to remain in-situ. Remove under controlled non-friable asbestos removal conditions prior to refurbishment or demolition works by a Class B (non-friable) licensed asbestos removal contractor in accordance with relevant State Regulations, Compliance Codes, Codes of Practice and Guidance Notes.	12

Line ID 12: External, Building 12 Client Services Coordinator Residence, Perimeter Verandas, Bathroom & Kitchen Wall Lining, Fibre Cement Sheet - Chrysotile Asbestos Detected

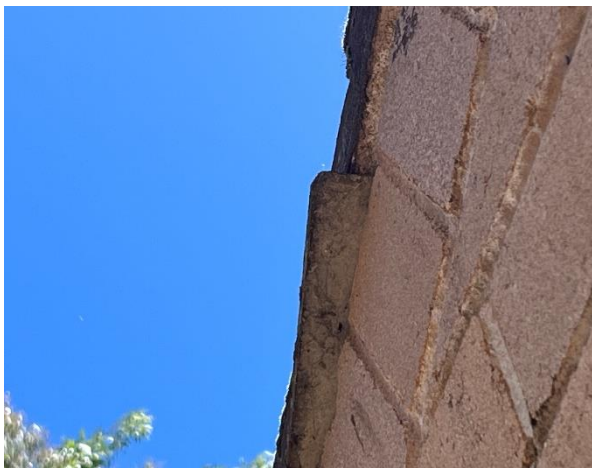
Line ID 13: External, Building 12 Client Services Coordinator Residence, Verandas, Gable End, Fibre Cement Sheet - Chrysotile Asbestos Detected

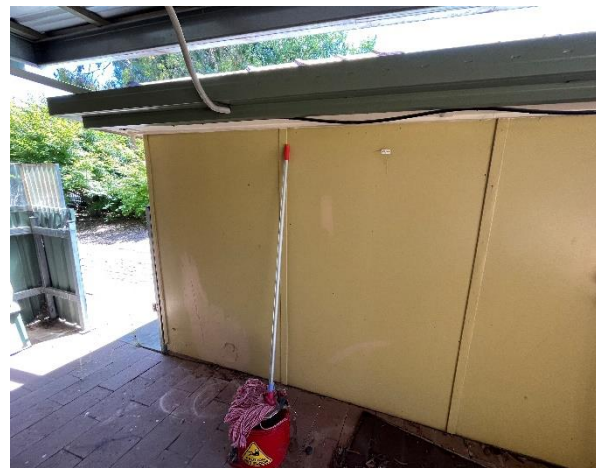
Area	Location	Material Description	Hazard	Reference No.	Result	Friable	Quantity	Risk Rating	Reinspect Date	Recommendations	Line ID
External	Building 12 Client Services Coordinator Residence / Perimeter Verandas / Gable End Tile Support Strips	Fibre Cement Sheet	Asbestos	Previously Sampled EP- 143.4	Chrysotile Asbestos Detected	Non-Friable	14 m	Low	5 Yearly Reinspection	Label as containing asbestos and maintain in current condition if to remain in-situ. Remove under controlled non-friable asbestos removal conditions prior to refurbishment or demolition works by a Class B (non-friable) licensed asbestos removal contractor in accordance with relevant State Regulations, Compliance Codes, Codes of Practice and Guidance Notes.	13
External	Building 12 Client Services Coordinator Residence / Perimeter Verandas / Garage Wall Lining	Fibre Cement Sheet	Asbestos	Previously Sampled EP- 169	Chrysotile Asbestos Detected	Non-Friable	30 m²	Low	5 Yearly Reinspection	Label as containing asbestos and maintain in current condition if to remain in-situ. Remove under controlled non-friable asbestos removal conditions prior to refurbishment or demolition works by a Class B (non-friable) licensed asbestos removal contractor in accordance with relevant State Regulations, Compliance Codes, Codes of Practice and Guidance Notes.	14

Line ID 14: External, Building 12 Client Services Coordinator Residence, Perimeter Verandas, Garage Wall Lining, Fibre Cement Sheet - Chrysotile Asbestos Detected

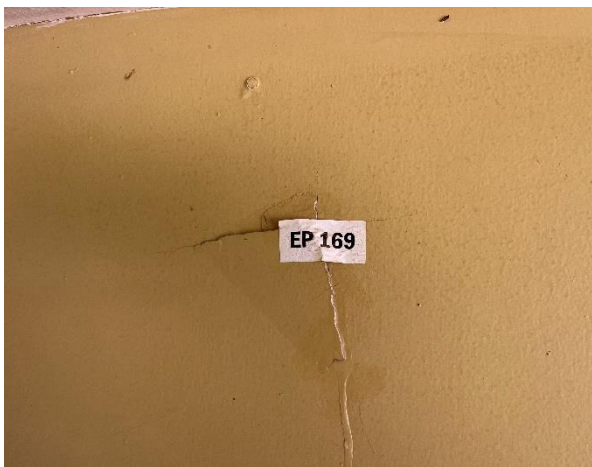
Line ID 14.1: External, Building 12 Client Services Coordinator Residence, Perimeter Verandas, Garage Wall Lining, Fibre Cement Sheet - Chrysotile Asbestos Detected

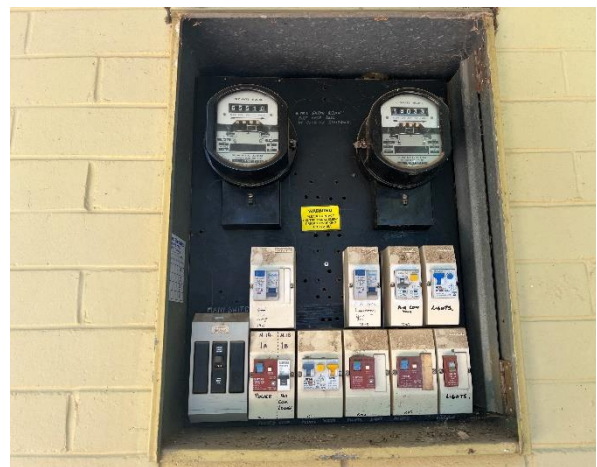
Line ID 15: External, Building 12 Client Services Coordinator Residence, Perimeter Verandas, South Side Electrical Box, Bituminous Backing Board - Chrysotile Asbestos Detected

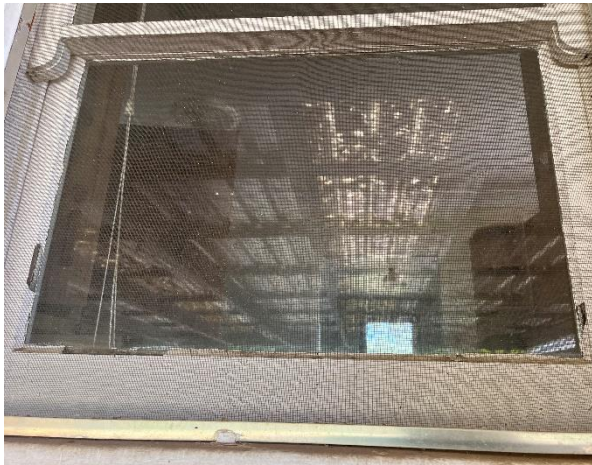
External	Building 12 Client Services Coordinator Residence / Perimeter Verandas / South Side Electrical Box	Bituminous Backing Board	Asbestos	Previously Sampled AF495.2	Chrysotile Asbestos Detected	Non-Friable	1 Unit	Low	5 Yearly Reinspection	Label as containing asbestos and maintain in current condition if to remain in-situ. Remove under controlled non-friable asbestos removal conditions prior to refurbishment or demolition works by a Class B (non-friable) licensed asbestos removal contractor in accordance with relevant State Regulations, Compliance Codes, Codes of Practice and Guidance Notes.	15
External	Building 12 Client Services Coordinator Residence / Perimeter Verandas / To All Timber External Windows	Window Caulking	Asbestos	AI09119	No Asbestos detected	-	80 m	-	-	-	16

Line ID 16: External, Building 12 Client Services Coordinator Residence, Perimeter Verandas, To All Timber External Windows, Window Caulking - No Asbestos detected

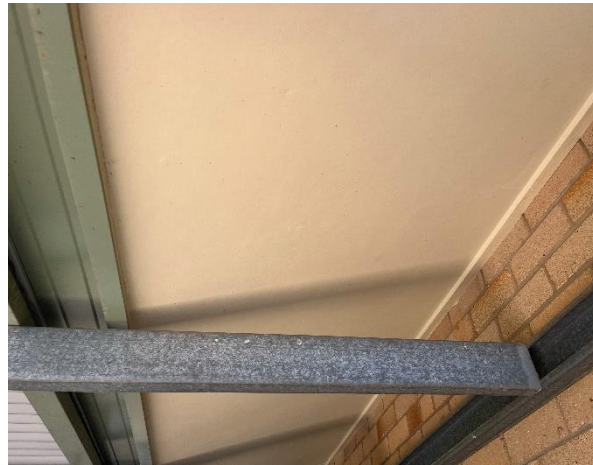
Line ID 18: External, Building 18 Lodges 1-4, Perimeter Verandas, Eave Lining, Fibre Cement Sheet - Chrysotile Asbestos Detected

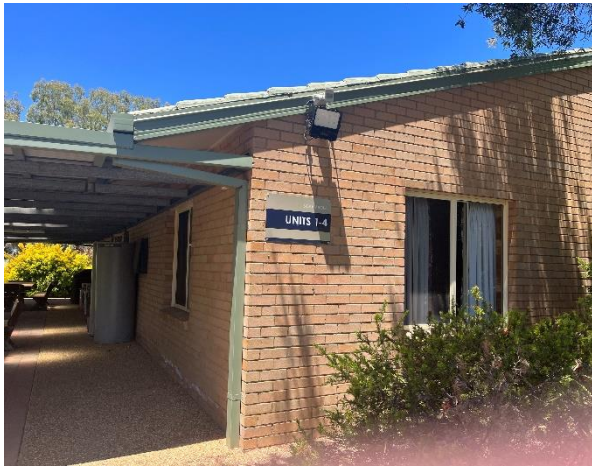
Area	Location	Material Description	Hazard	Reference No.	Result	Friable	Quantity	Risk Rating	Reinspect Date	Recommendations	Line ID
External	Building 18 Lodges 1-4 / Perimeter Verandas / Ceiling Lining to Internal and External Verandas	Fibre Cement Sheet	Asbestos	AI09116.2	No Asbestos Detected	-	120 m²	-	-		17
External	Building 18 Lodges 1-4 / Perimeter Verandas / Eave Lining	Fibre Cement Sheet	Asbestos	AI09113.2	Chrysotile Asbestos Detected	Non-Friable	30 m²	Low	5 Yearly Reinspection	Label as containing asbestos and maintain in current condition if to remain in-situ. Remove under controlled non-friable asbestos removal conditions prior to refurbishment or demolition works by a Class B (non-friable) licensed asbestos removal contractor in accordance with relevant State Regulations, Compliance Codes, Codes of Practice and Guidance Notes.	18
External	Building 18 Lodges 1-4 / Perimeter Verandas / Gable Ends Tile Support Strips	Fibre Cement Sheet	Asbestos	Previously Sampled EP-143.8	Chrysotile Asbestos Detected	Non-Friable	20 m	Low	5 Yearly Reinspection	Label as containing asbestos and maintain in current condition if to remain in-situ. Remove under controlled non-friable asbestos removal conditions prior to refurbishment or demolition works by a Class B (non-friable) licensed asbestos removal contractor in accordance with relevant State Regulations, Compliance Codes, Codes of Practice and Guidance Notes.	19

Line ID 19: External, Building 18 Lodges 1-4, Perimeter Verandas, Gable Ends Tile Support Strips, Fibre Cement Sheet - Chrysotile Asbestos Detected

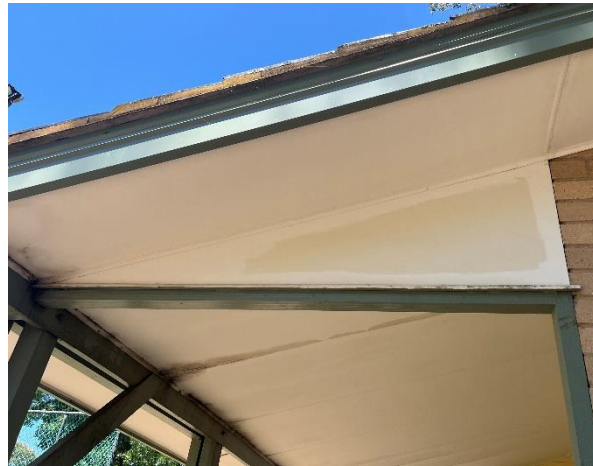
Line ID 22: External, Building 19 Lodges 5-8, Perimeter Verandas, Eave Lining, Fibre Cement Sheet - Chrysotile Asbestos Detected

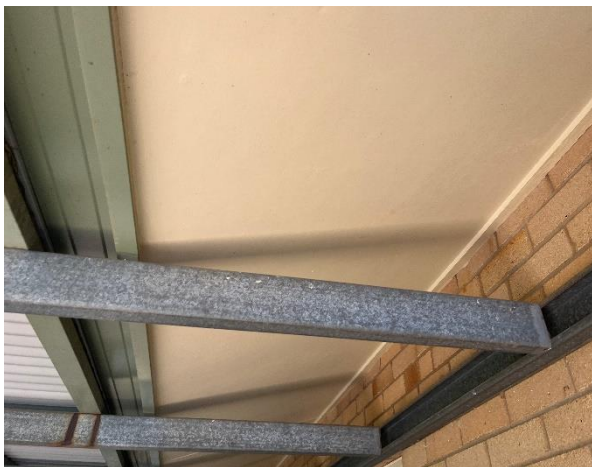
Line ID 25: External, Building 20 Lodges 9-12, Perimeter Verandas, Eave Lining, Fibre Cement Sheet - Chrysotile Asbestos Detected

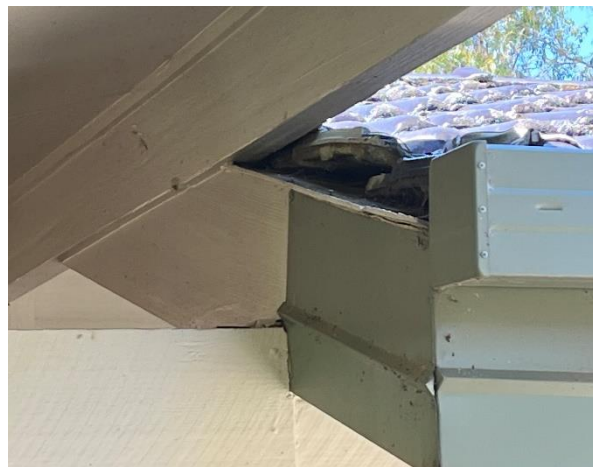
Area	Location	Material Description	Hazard	Reference No.	Result	Friable	Quantity	Risk Rating	Reinspect Date	Recommendations	Line ID
External	Building 20 Lodges 9-12 / Perimeter Verandas / Eave Lining	Fibre Cement Sheet	Asbestos	AI09113	Chrysotile Asbestos Detected	Non-Friable	30 m²	Low	5 Yearly Reinspection	Label as containing asbestos and maintain in current condition if to remain in-situ. Remove under controlled non-friable asbestos removal conditions prior to refurbishment or demolition works by a Class B (non-friable) licensed asbestos removal contractor in accordance with relevant State Regulations, Compliance Codes, Codes of Practice and Guidance Notes.	25
External	Building 20 Lodges 9-12 / Perimeter Verandas / Gable Ends Tile Support Strips	Fibre Cement Sheet	Asbestos	Previously Sampled EP-143.6	Chrysotile Asbestos Detected	Non-Friable	20 m	Low	5 Yearly Reinspection	Label as containing asbestos and maintain in current condition if to remain in-situ. Remove under controlled non-friable asbestos removal conditions prior to refurbishment or demolition works by a Class B (non-friable) licensed asbestos removal contractor in accordance with relevant State Regulations, Compliance Codes, Codes of Practice and Guidance Notes.	26

Line ID 26: External, Building 20 Lodges 9-12, Perimeter Verandas, Gable Ends Tile Support Strips, Fibre Cement Sheet - Chrysotile Asbestos Detected

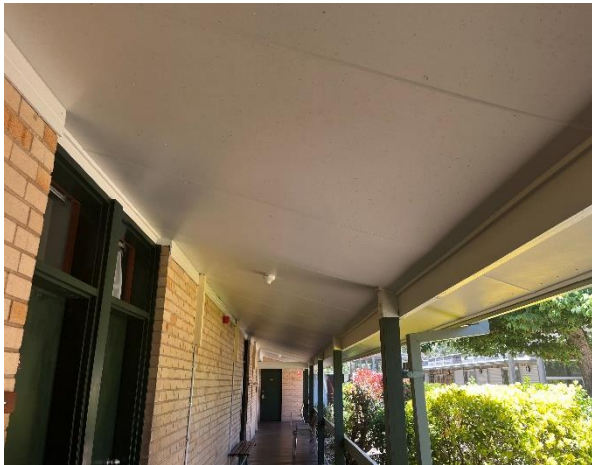
Line ID 27: External, Building 21 Ablutions Block, Entry and Covered Walkway Area, Ceiling Lining to Internal & External Verandas, Fibre Cement Sheet - Chrysotile Asbestos Detected

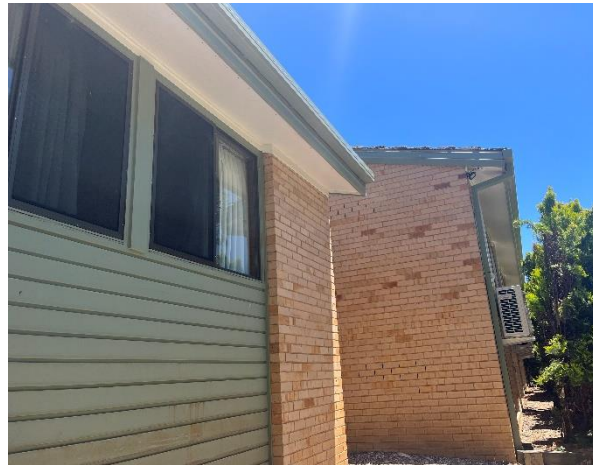
Line ID 28: External, Building 21 Ablutions Block, Entry and Covered Walkway Area, Eave Lining, Fibre Cement Sheet - Chrysotile Asbestos Detected

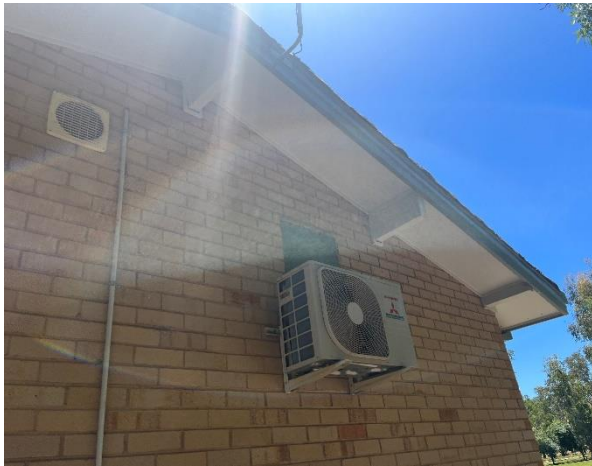
Line ID 29: External, Building 21 Ablutions Block, Entry & Covered Walkway Area, Gable Ends, Fibre Cement Sheet - Chrysotile Asbestos Detected

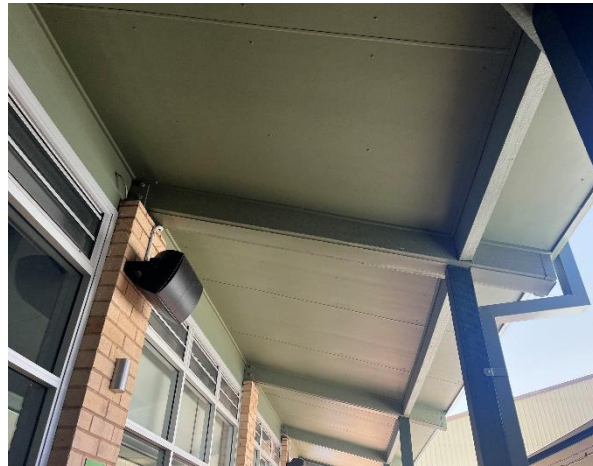
Line ID 32: External, Building 26 & 27 Kitchen, Entry and Covered Walkways, Eaves, Fibre Cement Sheet - No Asbestos Detected

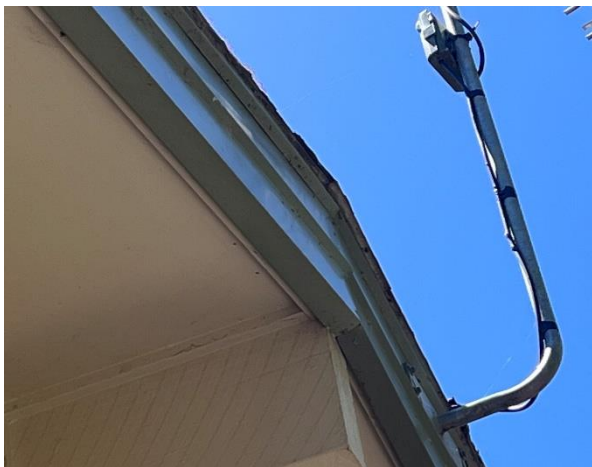
Line ID 34: External, Building 28 Admin, Entry Area, Eaves, Fibre Cement Sheet - No Asbestos Detected

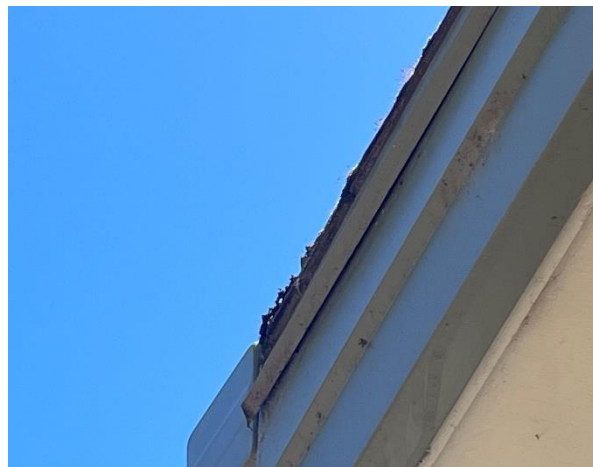
Line ID 35: External, Building 28 Admin, Entry Area, Gable Ends Tile Supports, Fibre Cement Sheet - Chrysotile Asbestos Detected

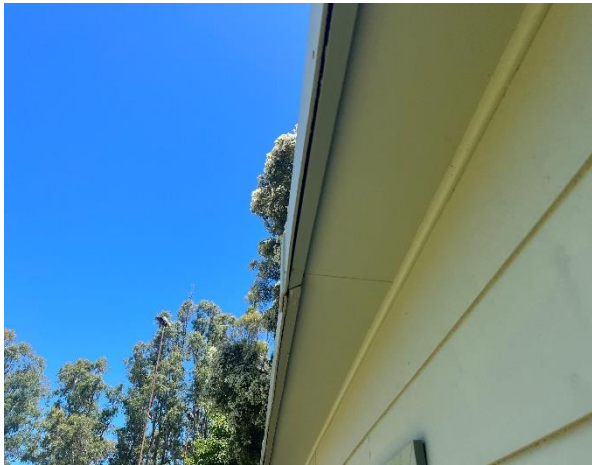
Line ID 36: External, Craft Shed, Perimeter Areas, Eaves, Fibre Cement Sheet - Chrysotile Asbestos Detected

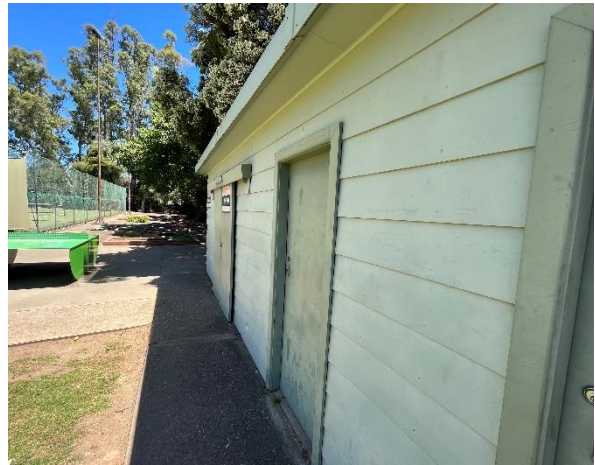
Line ID 37: External, Craft Shed, Perimeter Areas, Roof Edges and Returns, Fibre Cement Sheet - Chrysotile Asbestos Detected

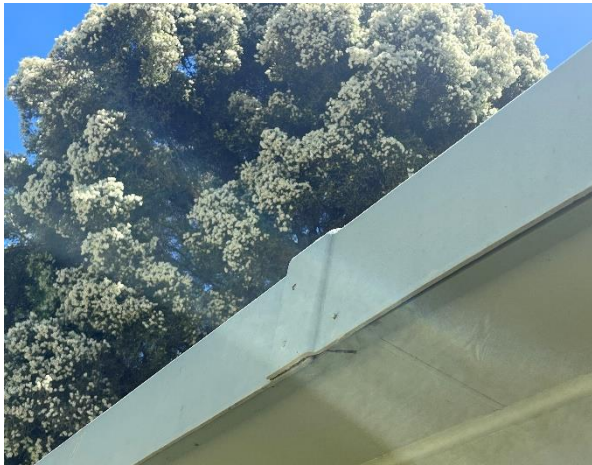
Line ID 37.1: External, Craft Shed, Perimeter Areas, Roof Edges and Returns, Fibre Cement Sheet - Chrysotile Asbestos Detected

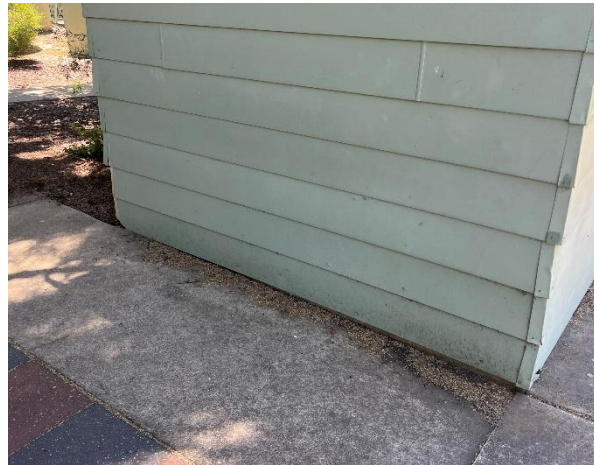
Line ID 38: External, Craft Shed, Perimeter Areas, Wall Cladding to All Sides, Fibre Cement Sheet - Chrysotile Asbestos Detected

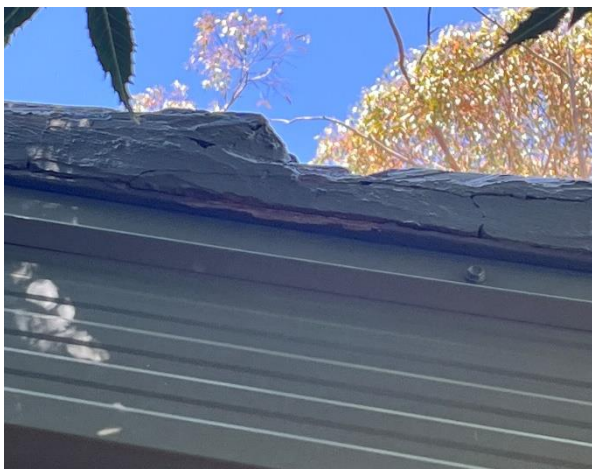
Line ID 40: External, Cricket Club House, Roof, Gable Ends of the Roof Tile Supports, Fibre Cement Sheet - Chrysotile Asbestos Detected

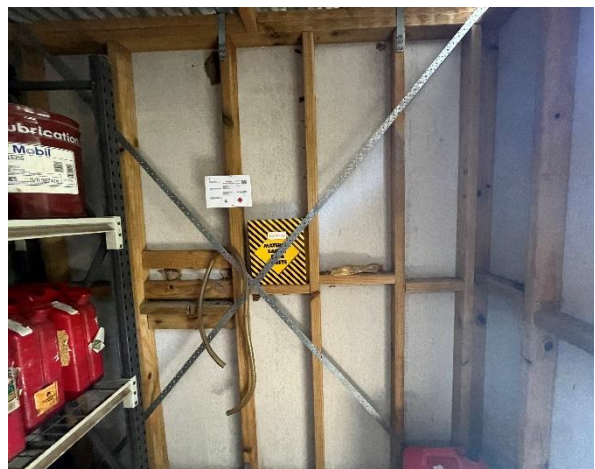
Line ID 41: External, Maintenance Fuel Store, Fuel Store, Wall Lining, Fibre Cement Sheet - Chrysotile Asbestos Detected

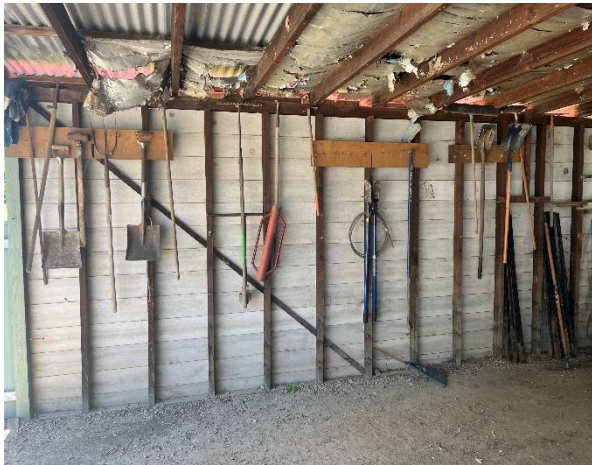
Line ID 42: External, Maintenance Garage, Garage, West Wall Cladding, Fibre Cement Sheet - Chrysotile Asbestos Detected

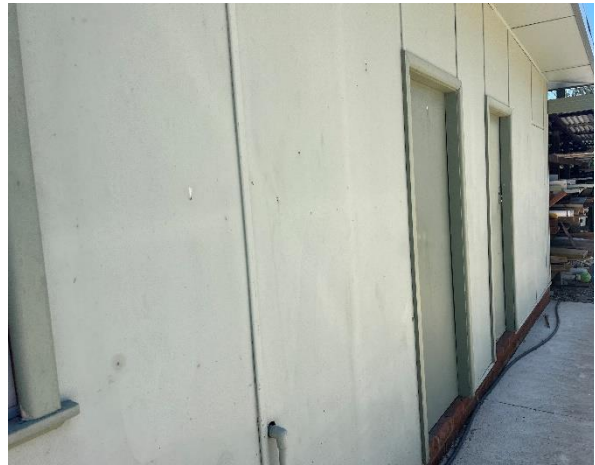
Line ID 42.1: External, Maintenance Garage, Garage, West Wall Cladding, Fibre Cement Sheet - Chrysotile Asbestos Detected

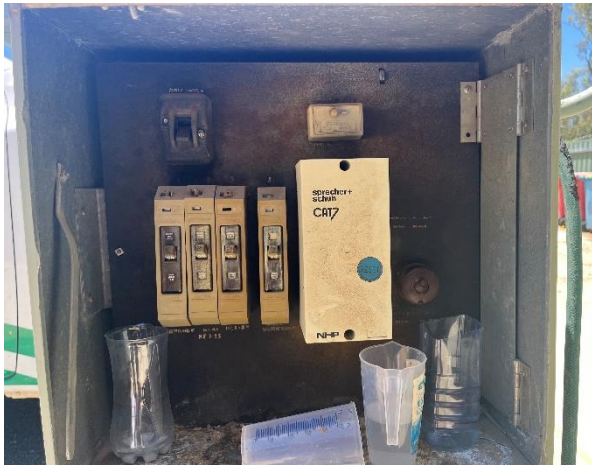
Line ID 43: External, Maintenance Workshop Metal, Externals, Adjacent Entry Roller Door, Bituminous Backing Board - Chrysotile Asbestos Detected

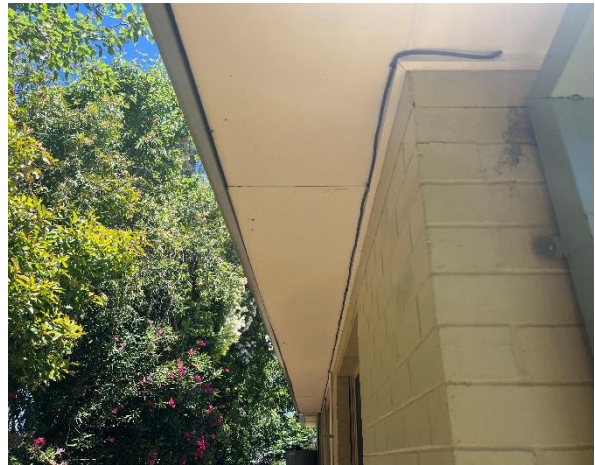
Line ID 45: External, Residence 16, Entry Area and Surrounds, Eaves Lining, Fibre Cement Sheet - Chrysotile Asbestos Detected

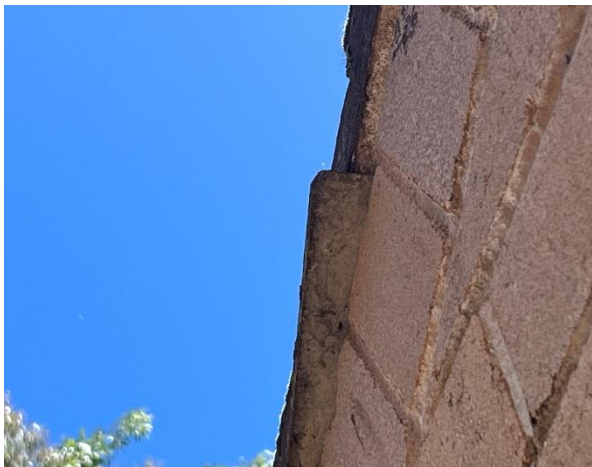
Line ID 46: External, Residence 16, Entry Area and Surrounds, Gable Ends Tile Support Strip, Fibre Cement Sheet - Chrysotile Asbestos Detected

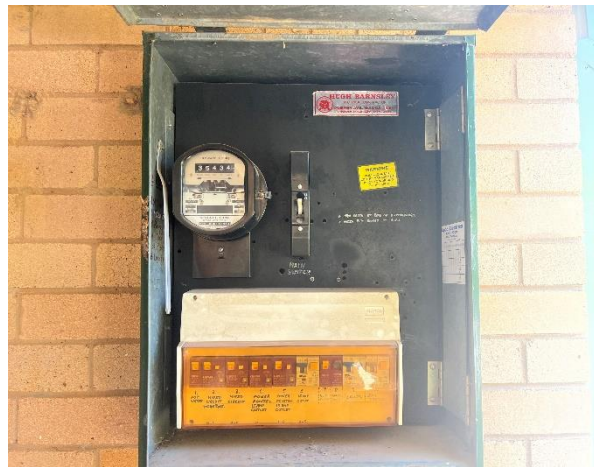
Line ID 47: External, Residence 16, Entry Area and Surrounds, Southside Electrical Box, Bituminous Backing Board - Chrysotile Asbestos Detected

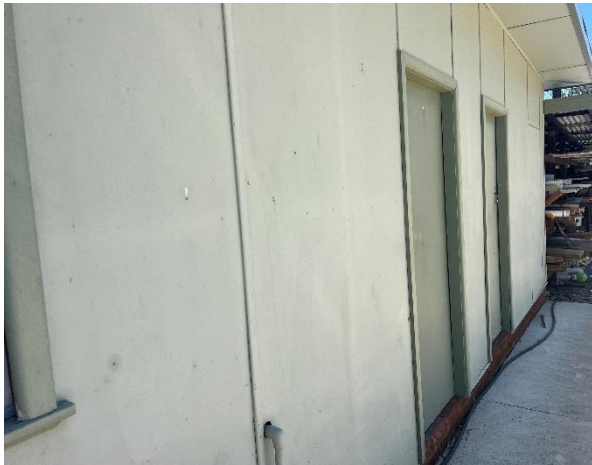
Line ID 48: External, Site 17 Maintenance Workshop Wood, Entry Area, Wall Cladding & Eaves, Fibre Cement Sheet - Chrysotile Asbestos Detected

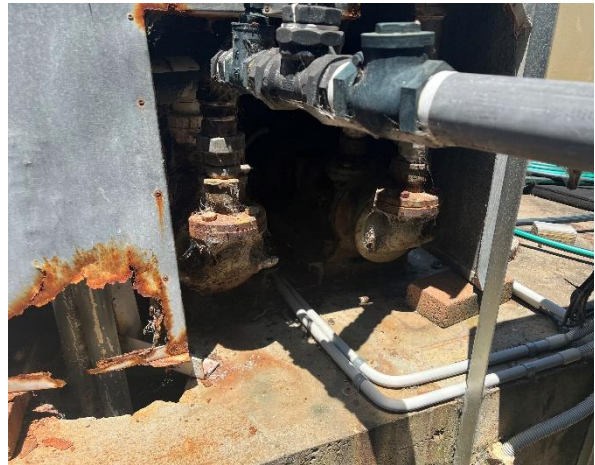
Line ID 49: External, Site 17 Maintenance Workshop Wood, Entry Area, Adjacent the Garage, Water Pump Pipework Gaskets, Gasket Material - Chrysotile Asbestos Detected

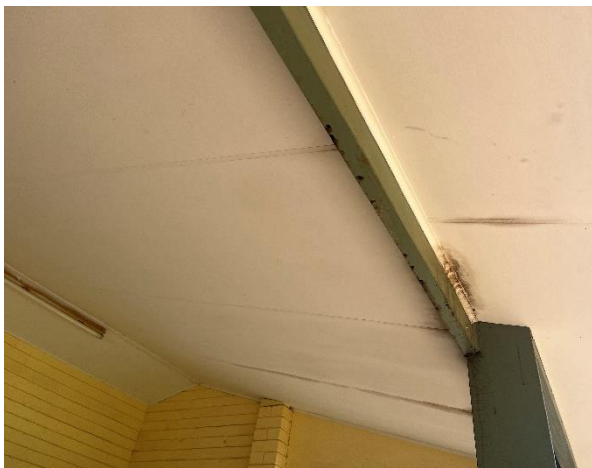
Line ID 50: External, Tennis Club House, Kitchen and Covered Area, Awning Lining, Fibre Cement Sheet - Chrysotile Asbestos Detected

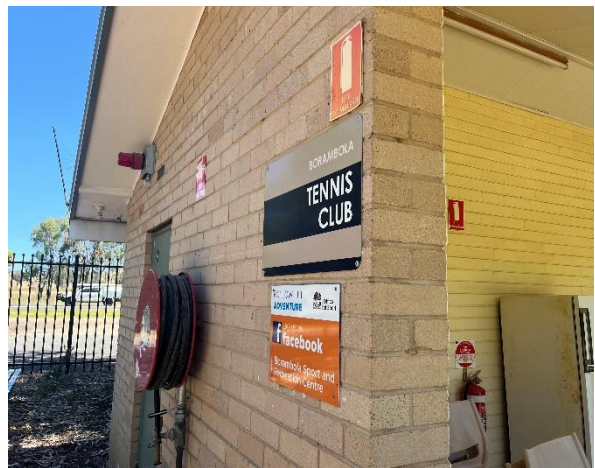
Line ID 52: External, Tennis Club House, Kitchen and Covered Area, Eaves, Fibre Cement Sheet - Chrysotile Asbestos Detected

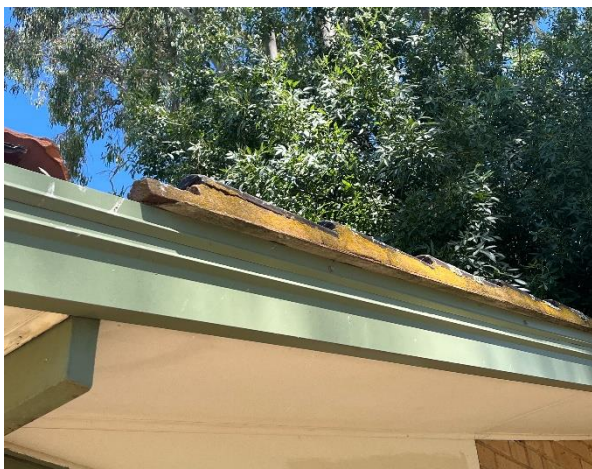
Line ID 53: External, Tennis Club House, Kitchen and Covered Area, Gabled Roof Ends Tile Edge Support, Fibre Cement Sheet - Chrysotile Asbestos Detected

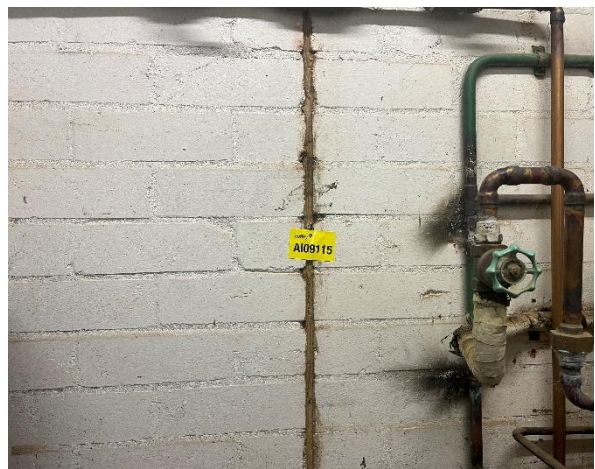
Line ID 60: Internal, Building 21 Ablutions Block, Boiler Room, Between Bricks to Wall, Construction Joint Mastic - Chrysotile Asbestos Detected

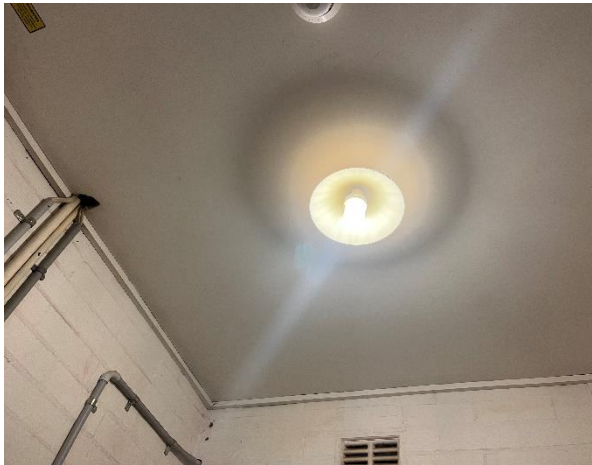
Line ID 61: Internal, Building 21 Ablutions Block, Boiler Room, Ceiling Lining to the Boiler and Cleaners Room, Fibre Cement Sheet - Chrysotile Asbestos Detected

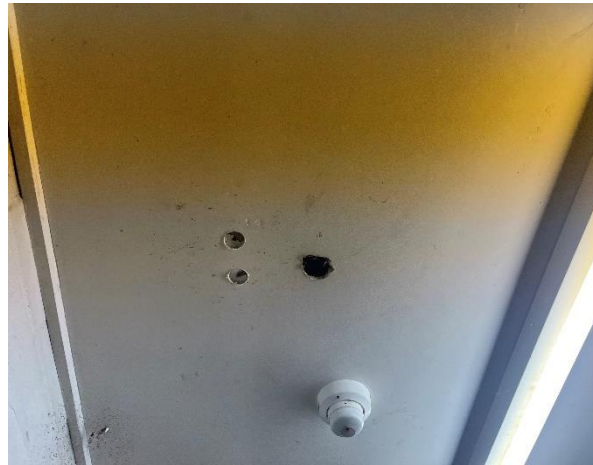
Line ID 61.1: Internal, Building 21 Ablutions Block, Boiler Room, Ceiling Lining to the Boiler and Cleaners Room, Fibre Cement Sheet - Chrysotile Asbestos Detected

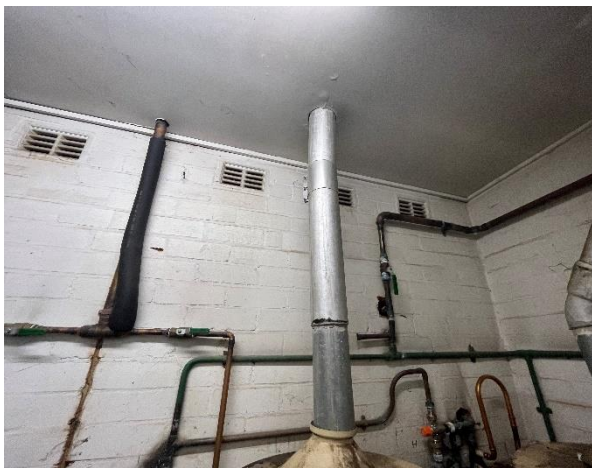
Line ID 62: Internal, Building 21 Ablutions Block, Boiler Room, Flue Pipes, Moulded Fibre Cement Pipes - Chrysotile & Amosite Asbestos Detected

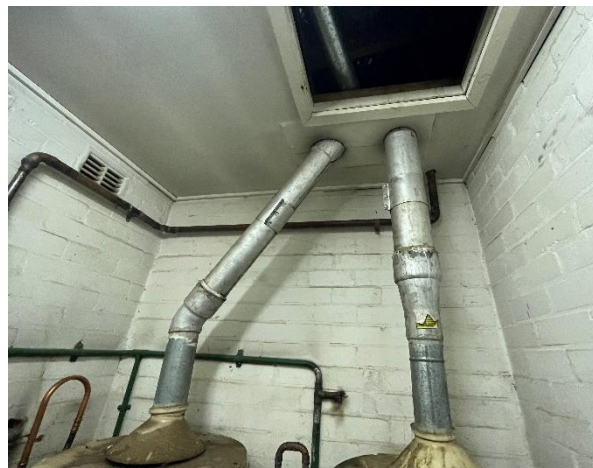
Line ID 62.1: Internal, Building 21 Ablutions Block, Boiler Room, Flue Pipes to Hot Water Units, Moulded Fibre Cement Pipes - Chrysotile & Amosite Asbestos Detected

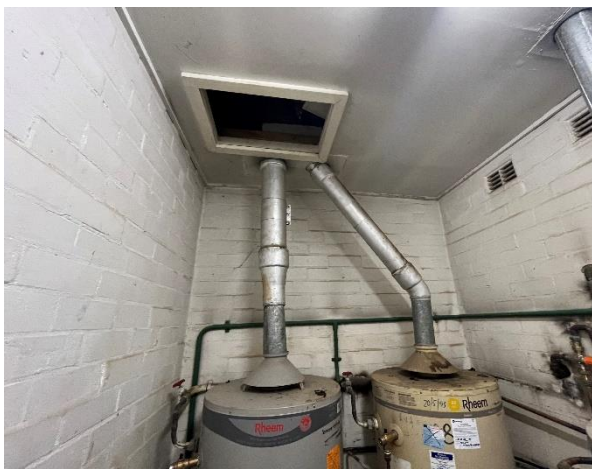
Line ID 62.2: Internal, Building 21 Ablutions Block, Boiler Room, Flue Pipes to Hot Water Units, Moulded Fibre Cement Pipes - Chrysotile & Amosite Asbestos Detected

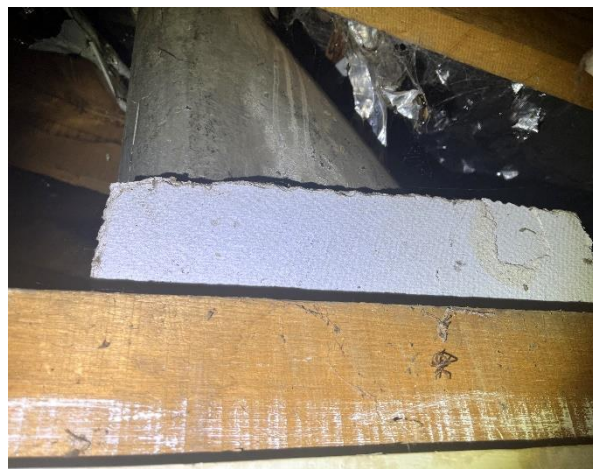
Line ID 63: Internal, Building 21 Ablutions Block, Boiler Room, Packer Within the Ceiling to the Hatch, Fibre Cement Sheet Packer - Chrysotile Asbestos Detected

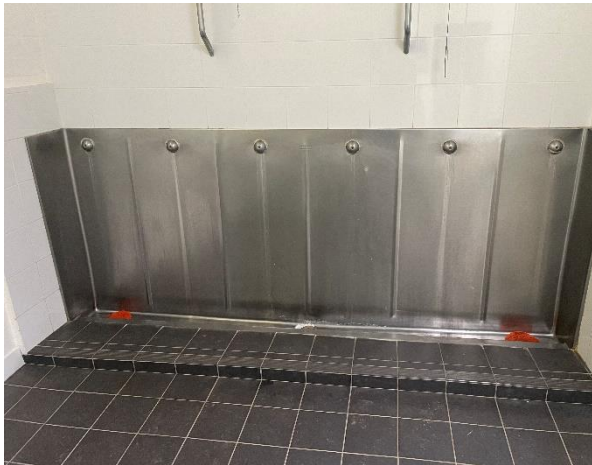
Line ID 64: Internal, Building 21 Ablutions Block, Male Toilets and Change, Behind the Urinal, Bituminous Membrane - Suspected Asbestos

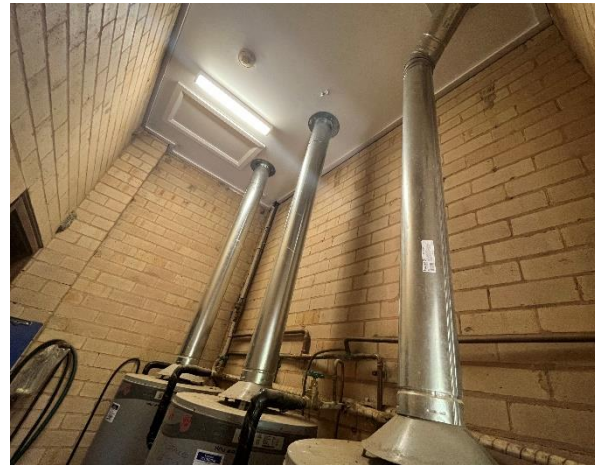
Line ID 65: Internal, Building 26 & 27 Kitchen & Dining Room, Boiler Room, to Boiler, Flue Pipes - Chrysotile Asbestos Detected

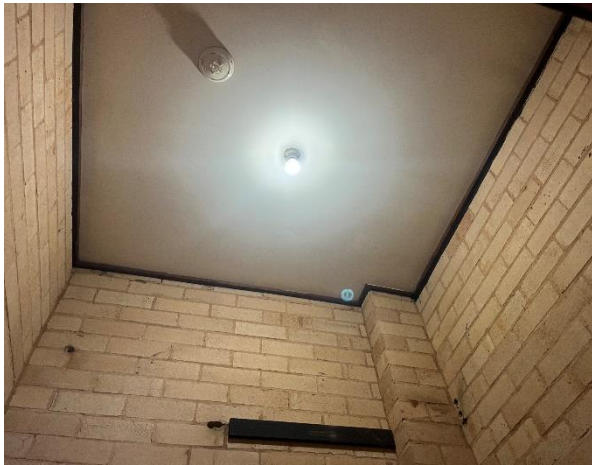
Line ID 68: Internal, Building 26 & 27 Kitchen & Dining Room, Cleaners Room, Ceiling Lining, Fibre Cement Sheet - Chrysotile Asbestos Detected

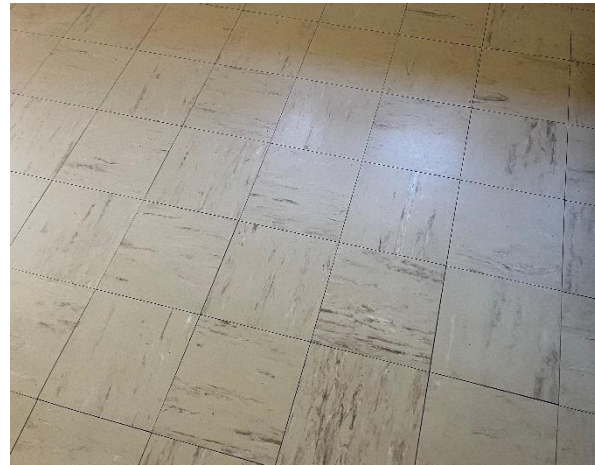
Line ID 72: Internal, Building 26 & 27 Kitchen & Dining Room, Staff Area, Throughout the Kitchen Staff Area, Beige Vinyl Floor Tiles - Chrysotile Asbestos Detected

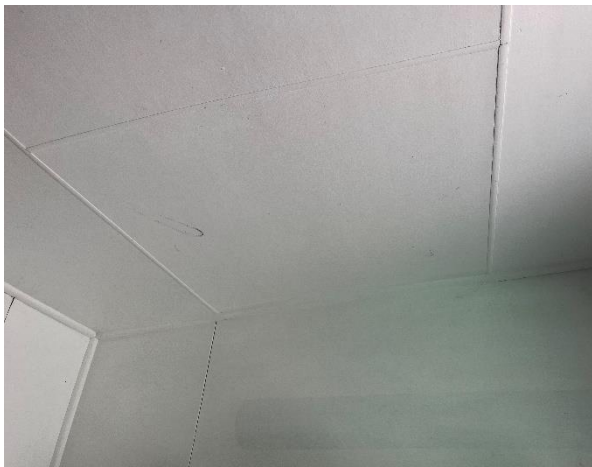
Line ID 73: Internal, Craft Shed, Bush craft and Sports Store, Ceiling and Wall Linings, Fibre Cement Sheet - Chrysotile Asbestos Detected

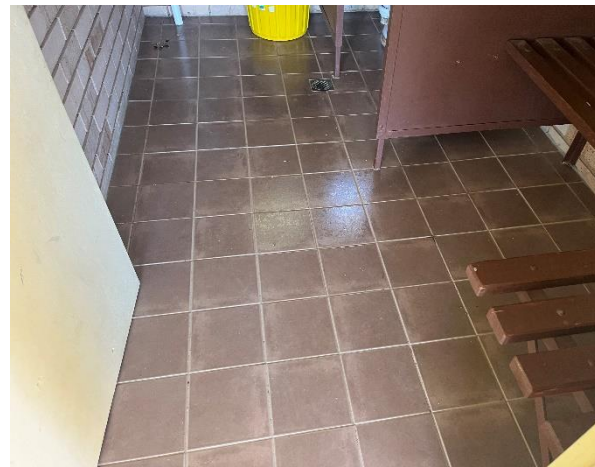
Line ID 74: Internal, Cricket Club House, Toilets, Below Ceramic Tiles to the Floor, Compressed Cement Sheet - Suspected Asbestos

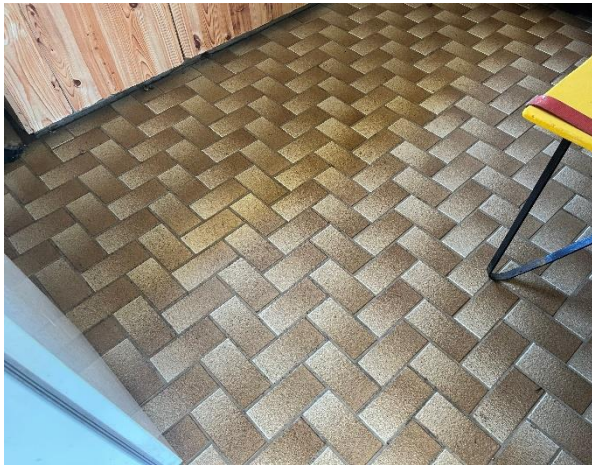
Line ID 75: Internal, Cricket Club House, Veranda, Below Ceramic Tiles to the Floor, Compressed Cement Sheet - Suspected Asbestos

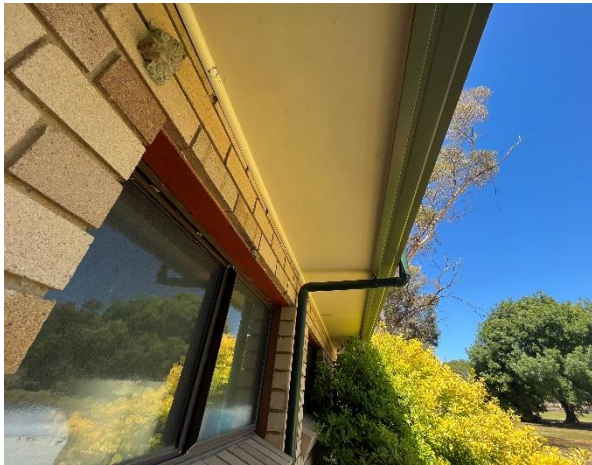
Line ID 76: Internal, Cricket Club House, Veranda, Eaves, Fibre Cement Sheet - Chrysotile Asbestos Detected

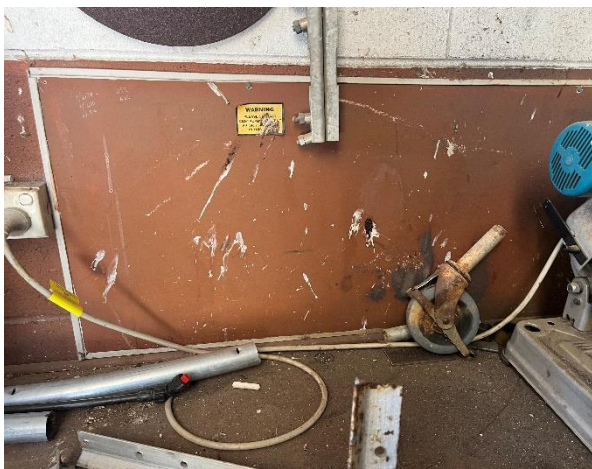
Line ID 77.1: Internal, Maintenance Workshop Metal, Workshop, To Wall Behind Work Bench, Fibre Cement Sheet - Chrysotile Asbestos Detected

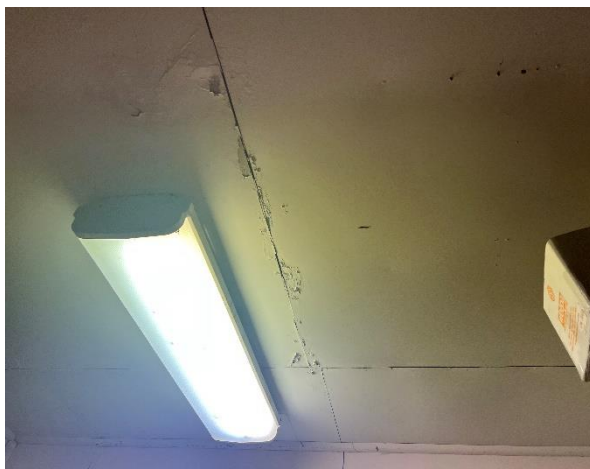
Line ID 78: Internal, Site 17 Maintenance Workshop Wood, Workshop and Office, Ceiling Lining, Fibre Cement Sheet - Chrysotile Asbestos Detected

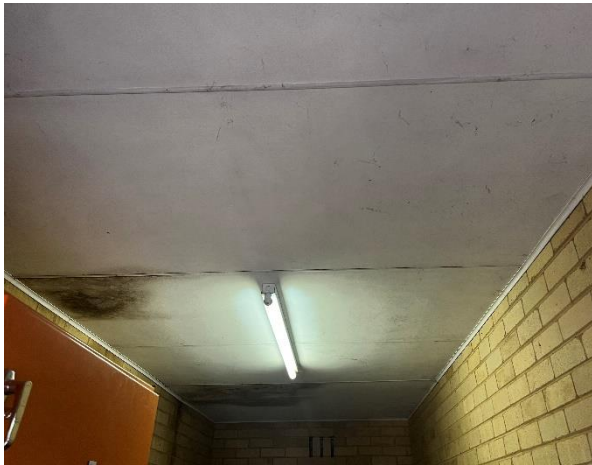
Line ID 79: Internal, Tennis Club House, Rear Electrical Cupboard, Ceiling Lining, Fibre Cement Sheet - Chrysotile Asbestos Detected

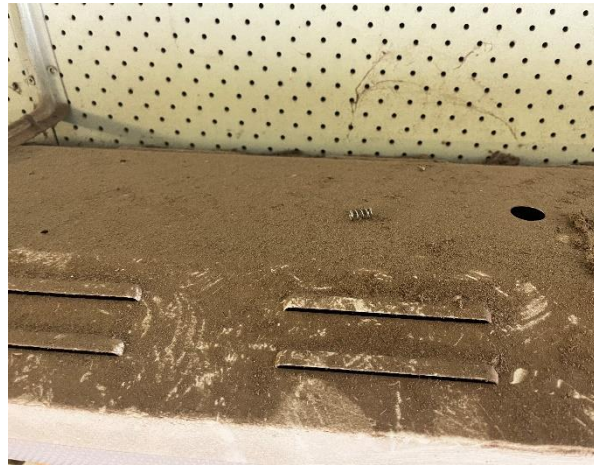
Line ID 80: Internal, Site 17 Maintenance Workshop Wood, Workshop and Office, To High level Ledges, Dust - Lead Detected (100mg/kg)

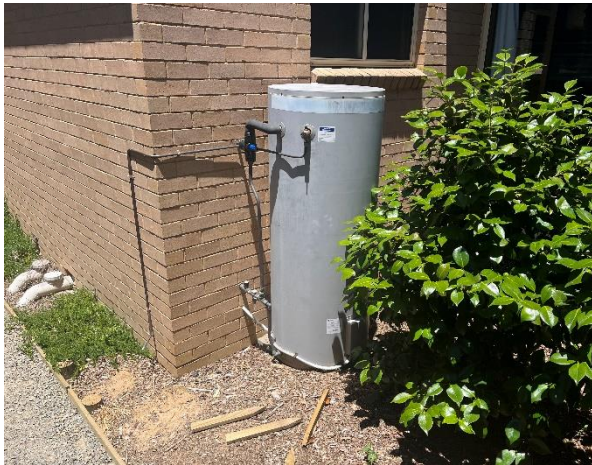
Line ID 81: External, Building 18 Lodges 1-4, Perimeter Verandas, Hot Water Units, Insulation Material - Suspected SMF

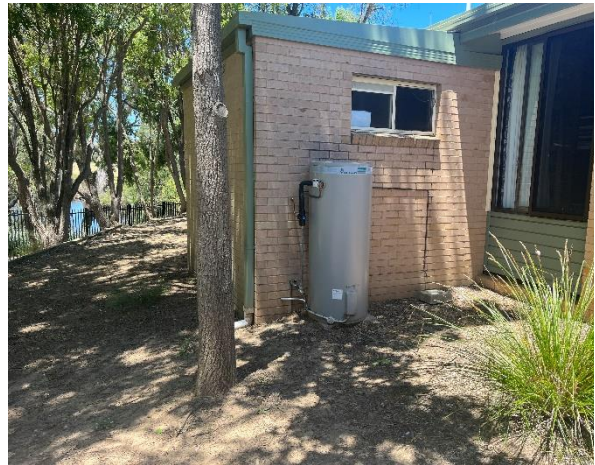
Line ID 82: External, Building 19 Lodges 5-8, Perimeter Verandas, Hot Water Units, Insulation Material - Suspected SMF

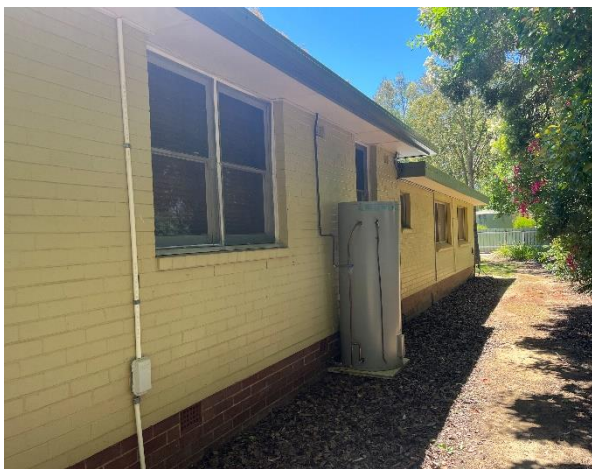
Line ID 83: External, Building 20 Lodges 9-12, Perimeter Verandas, Hot Water Units, Insulation Material - Suspected SMF

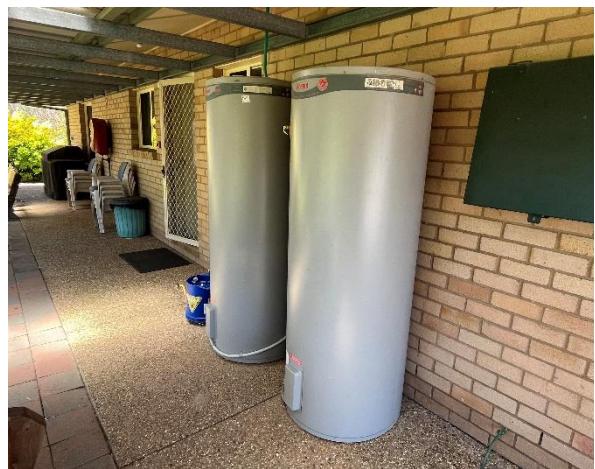
Line ID 84: External, Building 22, Entry Area, Hot Water Units to Patio Area, Insulation Material - Suspected SMF

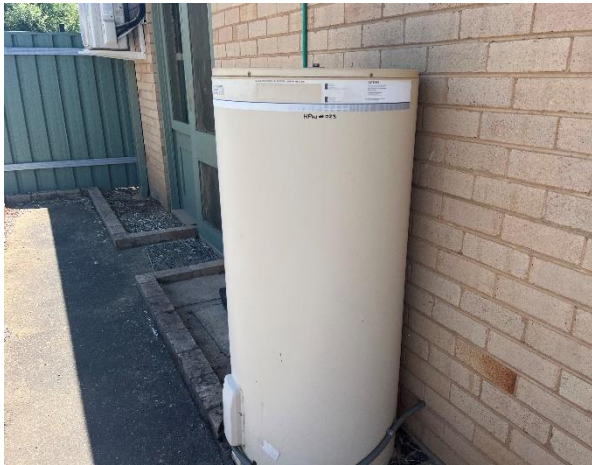
Line ID 85: External, Residence 16, Entry Area and Surrounds, Hot Water Unit, Insulation Material - Suspected SMF
