Office of Sport

Asbestos and Hazardous Materials Reinspection Assessment

Borambola Sports & Recreation Centre

03/02/2023

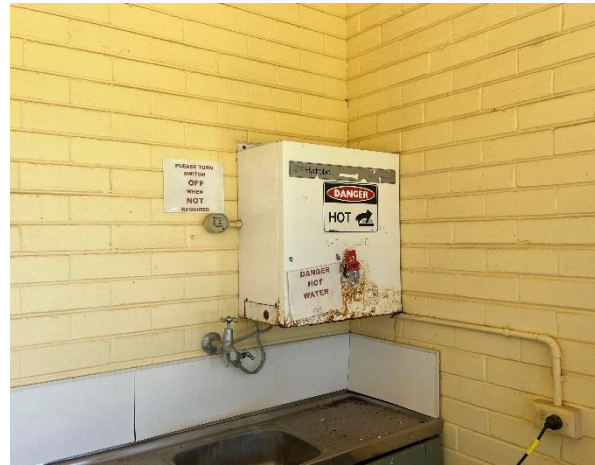
Line ID 86: External, Tennis Club House, Kitchen and Covered Area, Hot Water Unit, Insulation Material - Suspected SMF

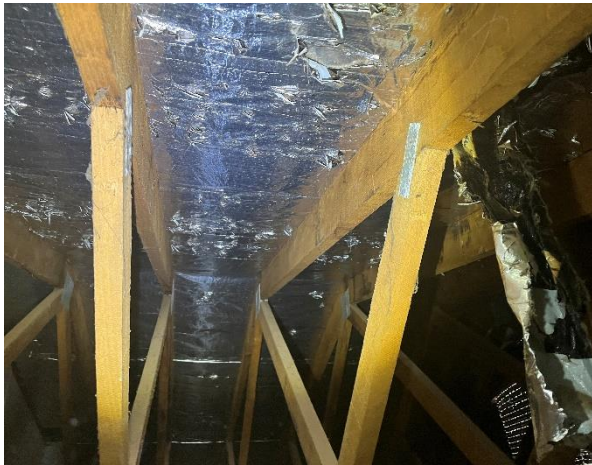
Line ID 91: Internal, Building 21 Ablutions Block, Ceiling Void, To the Underside of the Roof, Sarking Insulation - Suspected SMF

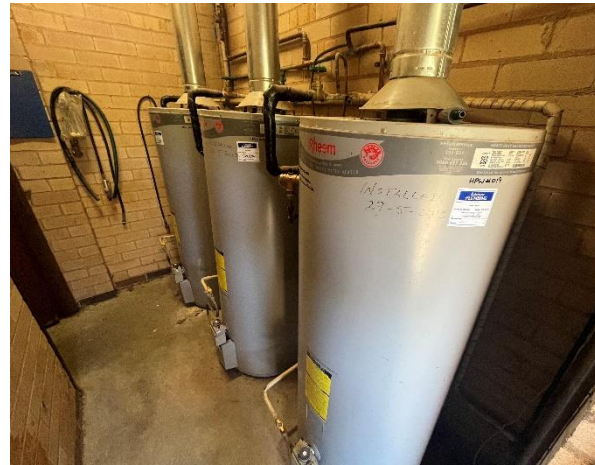
Line ID 94: Internal, Building 26 & 27 Kitchen & Dining Room, Boiler Room, Hot Water Units, Insulation Material - Suspected SMF

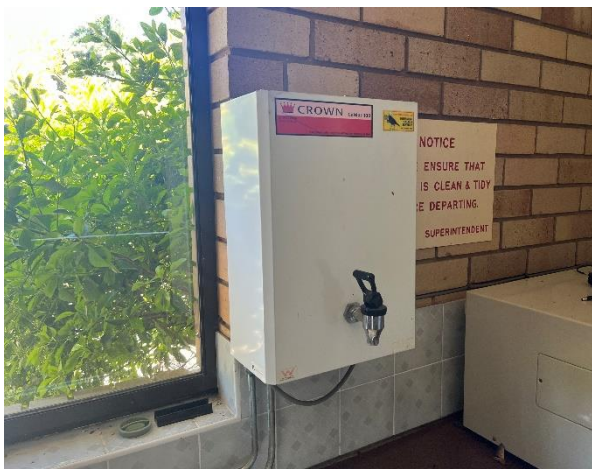
Line ID 97: Internal, Cricket Club House, Kitchen, Hot Water Unit, Insulation Material - Suspected SMF
