Office of Sport

Asbestos and Hazardous Materials Reinspection Assessment

Borambola Sports & Recreation Centre

03/02/2023

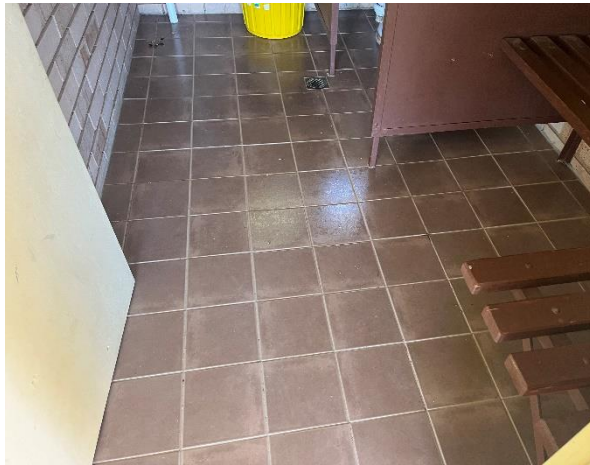
Line ID 75.1: Internal, Cricket Club House, Veranda, Below Ceramic Tiles to the Floor, Compressed Cement Sheet - Suspected Asbestos

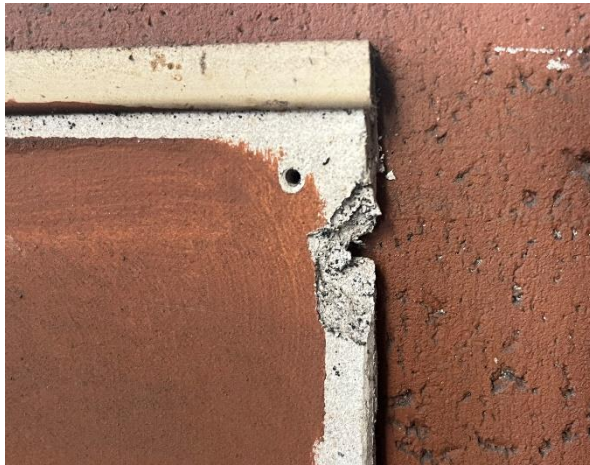
Line ID 76: Internal, Cricket Club House, Veranda, Eaves, Fibre Cement Sheet - Chrysotile Asbestos Detected
